Assessment of the risks of landslides in Thawr Mountain in Makkah by measuring slope stability factors and geographic information system

Fathy Shaaban, Turki Habeebullah, Safwat Gabr, Waleed El-Saud, Essam Morsi, Abd Allah Ghoram Allah
Institute of the Custodian of the Two Holy Mosques for Hajj and Umrah Research - Umm Al Qura University

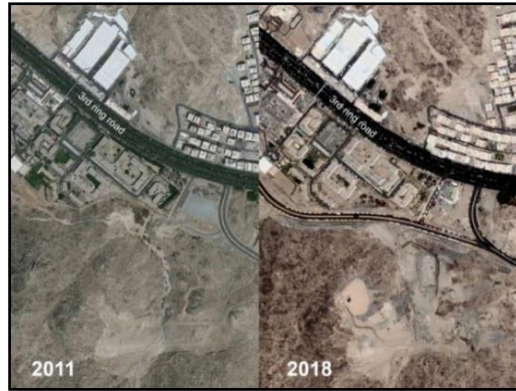
Fig.(3): Satellite images acquired in 2011 and 2018 showing the locations of rock cutting and land filling activities to the northeast of Gabal Thawr.

The identification of potential zone for landslide hazards at Gabal Thawr requires the integration of multiple datasets including recent satellite images, DEM, geological data and detailed fieldwork. The rock-cut slopes can easily be observed using satellite images, as the spectral reflectance of the excavated rocks is markedly higher than non-excavated outcrops. Another mean of its identification is the shadow formed from the resulted artificial cliffs and the change detection using a time series of satellite images (Figure 3).

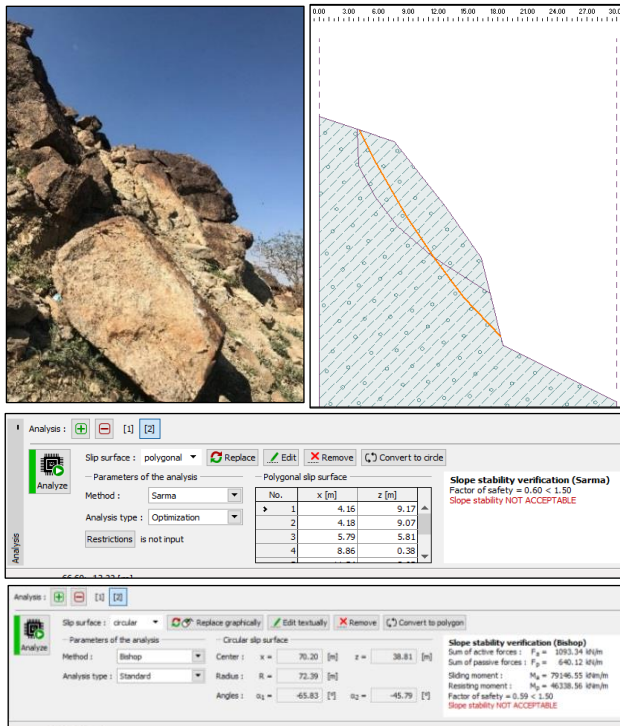
Fig.(9): An illustrative example for the study of slope stability at a part of the ascending road of Mount Thawr.

The GEO5 2018 slope stability software was used to examine the stability of some regions on the ascending road escarpment as represented in figures 9&10, the slope stability values resulting from the two cases was 0.6 and 1.12 respectively theses values are less than 1.5 which represent the safe slope stability factor.

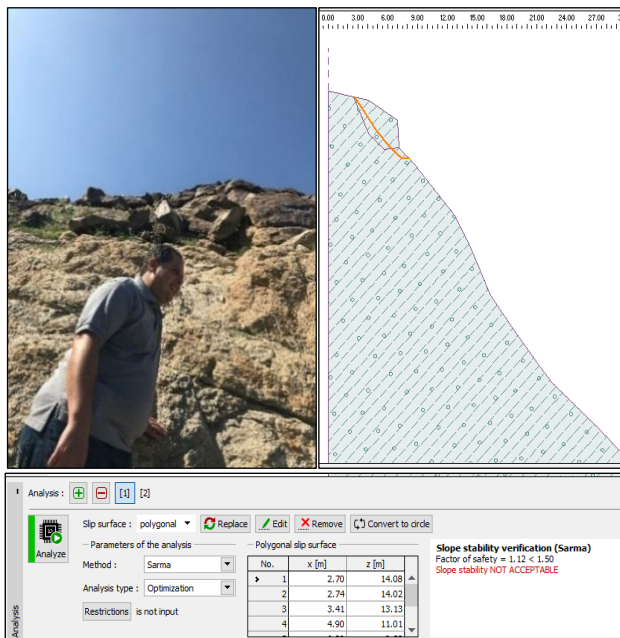
Fig.(10): An illustrative example for the study of slope stability at a part of the ascending road of Mount Thawr.
